Quality Connection

FALL 2017 VOL. 12 | NO. 3

A tight fit

New part improves hub vacuum sealing

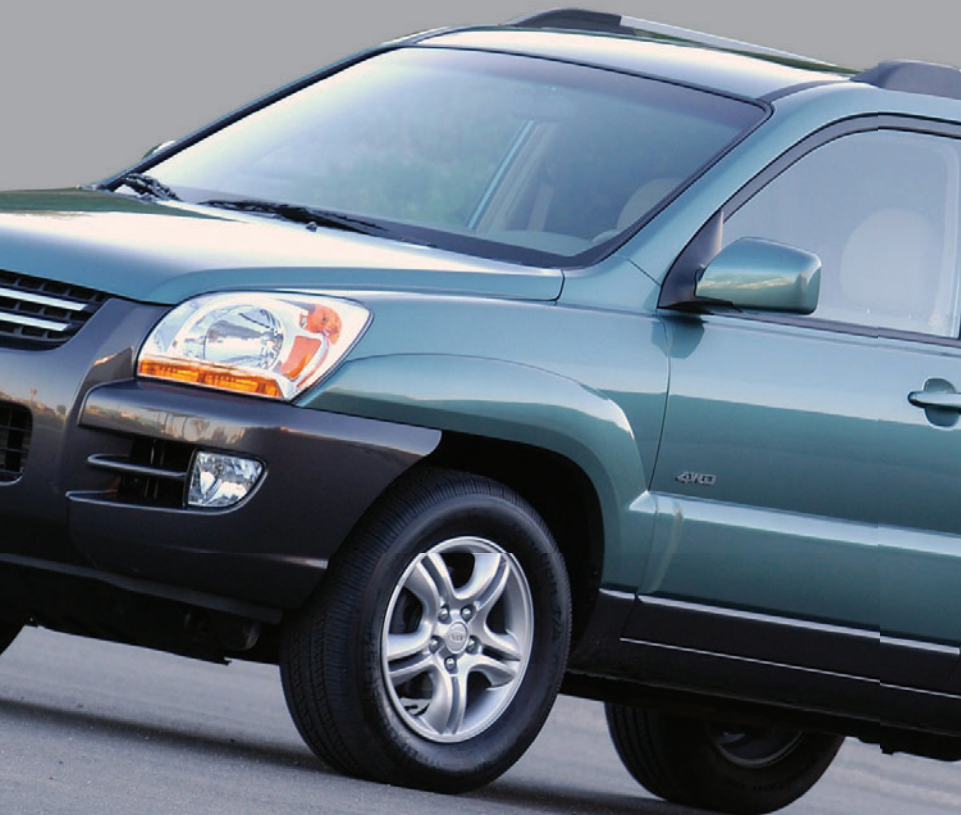
In order to improve hub vacuum sealing during 4WD operation for 1998-2001 Sportage 4WD vehicles, we recommend using a new inner seal, along with corresponding revisions to knuckles and CV shafts. A service kit is available from Kia to retrofit the new seal; installation instructions are described in this article.

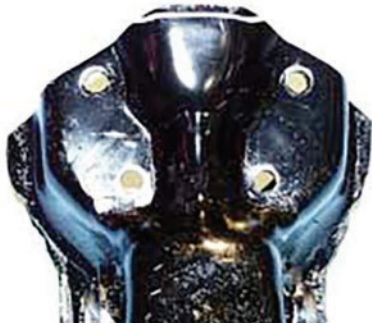
8

Mark Control Arm as Shown, at 1/8" from the Edge.

8. Mark the edge of the lower control arm at 1/8-inch from edge as shown.

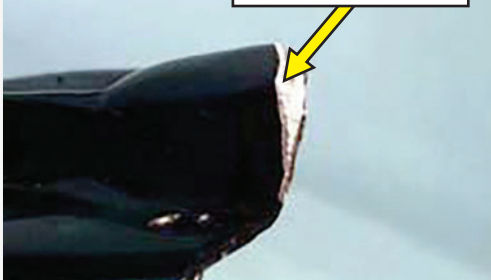
9

Grind Edge as Shown, to 1/8" Mark Made in Previous Step

9. Remove the 1/8-inch of material marked in Step 8 by grinding the edge at an angle as shown. Touch up reworked area with black paint.

Notice: This material removal on the lower control arm is necessary to prevent

interference between the lower control arm and the new knuckle and/or the inner seal dust shield on the CV shaft.

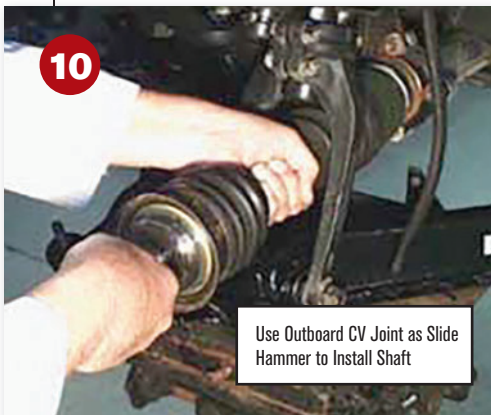
10

Use Outboard CV Joint as Slide Hammer to Install Shaft

10. Inspect the retaining ring on the output shaft of the front axle, replace if damaged. Position/rotate the new drive shaft to line up with the splines in the front axle output shaft, then install by pushing it in place, using the outer part of shaft as a slide hammer. Unload the suspension and remove the jack.

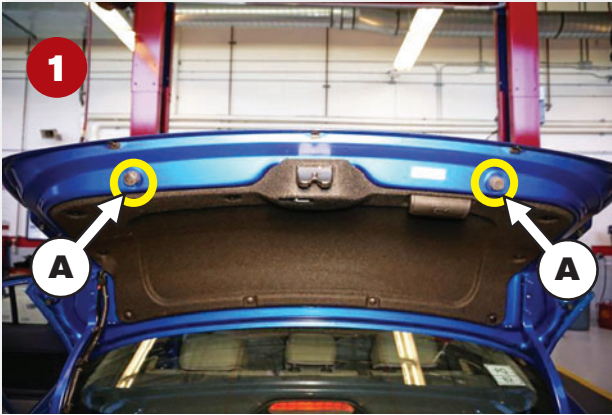
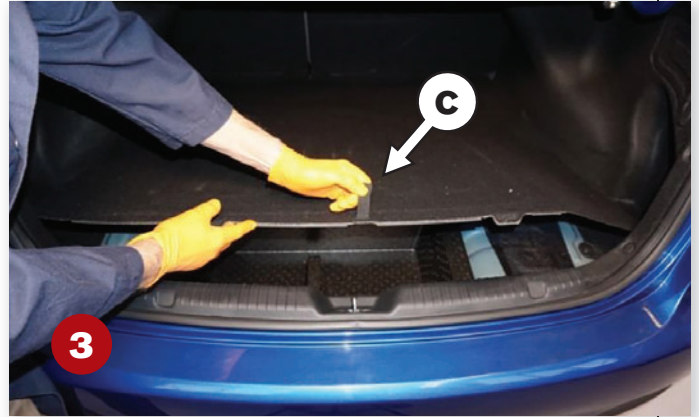
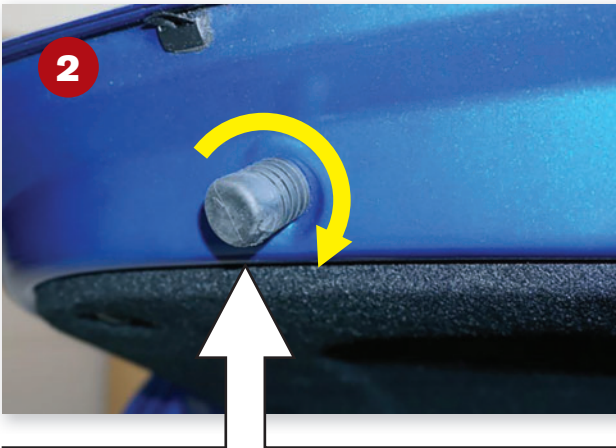
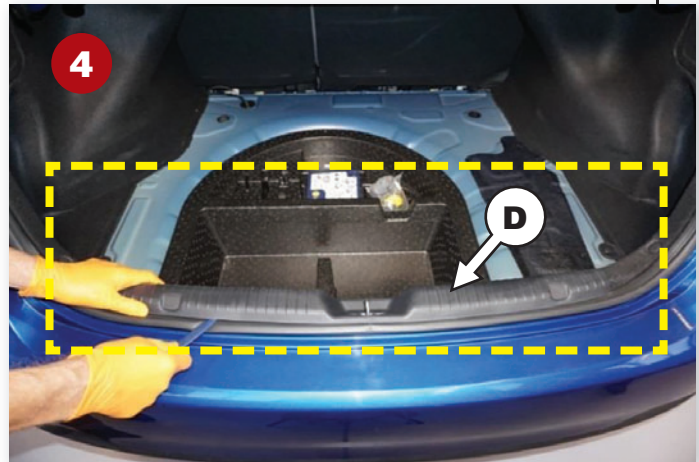
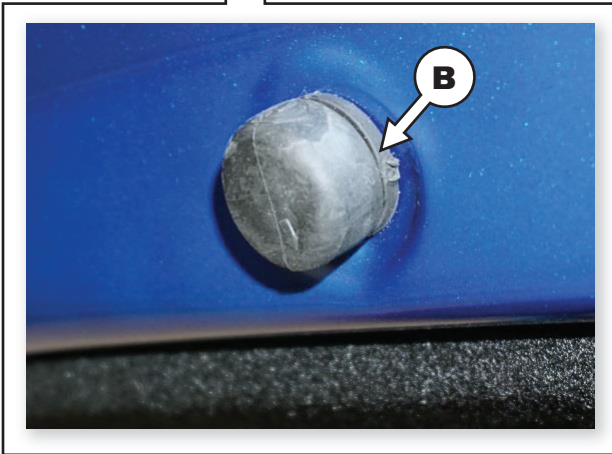
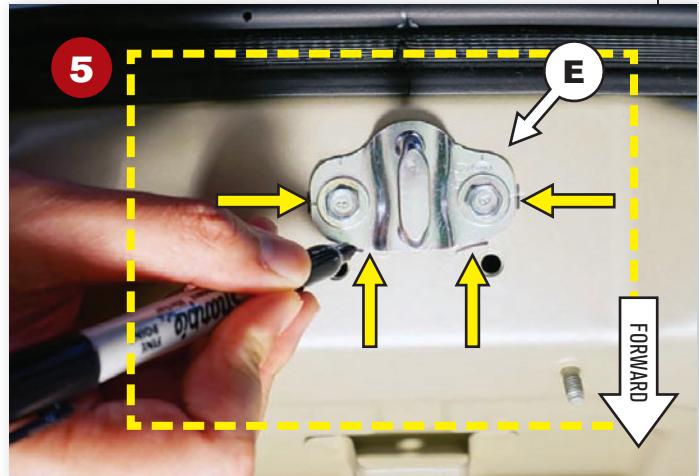
1. Locate the two trunk rubber bumpers (A).

2. Check and adjust, if necessary, the height of the rubber bumper until only one adjustment line (B) is visible above the trunk surface.

3. Remove the luggage compartment mat (C).

4. Carefully remove the trunk compartment trim (D).

5. Locate the striker and use a marker to make four reference marks (E) around the striker, as shown. Note: The reference marks will make it easier to measure striker movement after adjustment.

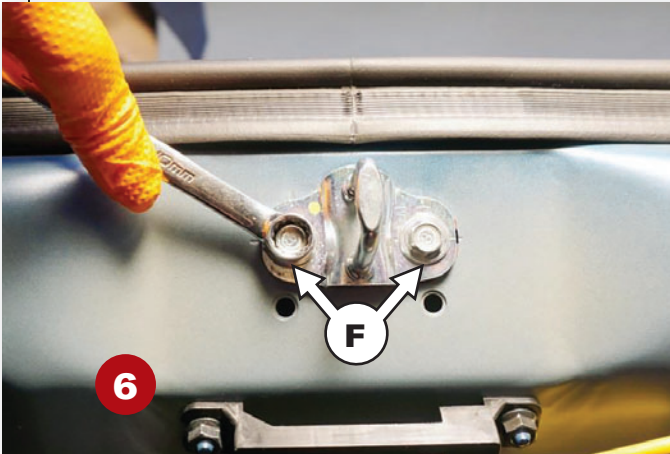
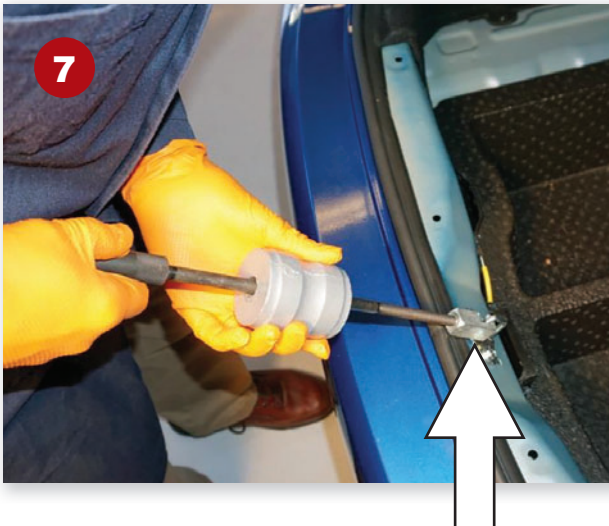
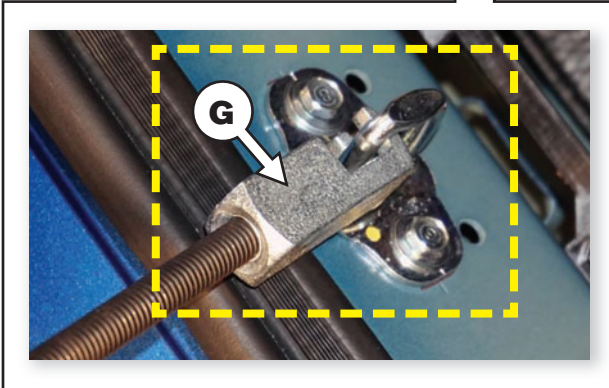
6. Loosen the two striker mounting bolts (F) by 1/3 of a turn. Note: Do not loosen the bolts past 1/3 of a turn. The bolts must remain tight.

7. Install a hook adaptor (G) onto the end of a slide hammer, or a similar tool, and install it onto the striker, as shown.

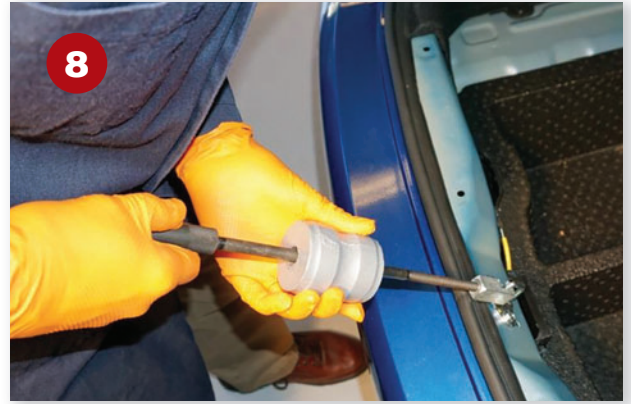
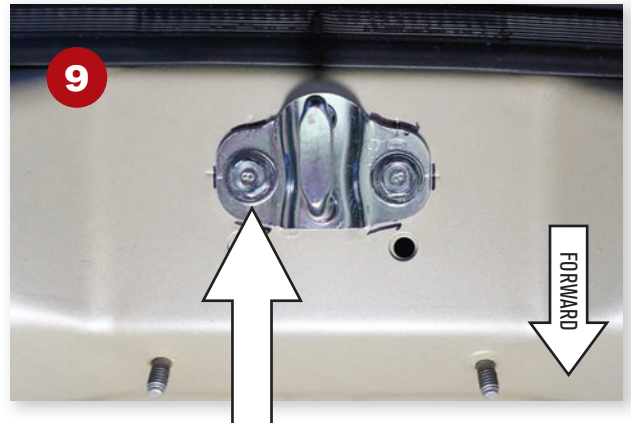
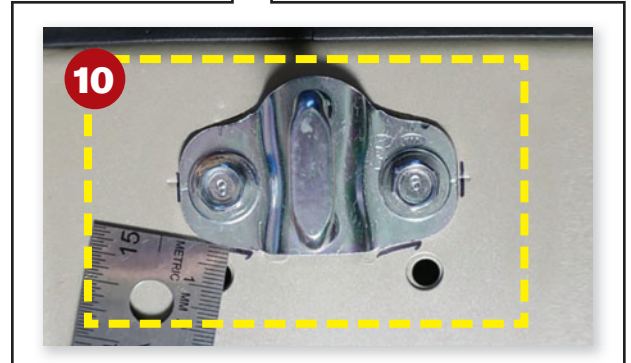
8. Use the slide hammer to pull straight back on the striker, as shown. Note: Do not allow the slide hammer to deviate laterally while adjusting the striker.

9. After completing the first pulling operation, use a ruler to measure the amount of striker adjustment, relative to the reference marks. Note: If more adjustment is required, repeat step 8 until the striker reaches the required adjustment. Required adjustment: 0.011" ~ 0.019" (0.27 ~ 0.49 mm)

10. After striker adjustment is complete, torque the striker mounting bolts to specification. Tightening Torque: 5.1 ~ 8.0 lb-ft (6.9 ~ 10.8 Nm)
